Manhole Inspection Summary

Manhole # S25GG1006MH

Insp Date: **10/27/08 11:24 AM**

Location Address: **4032 FALLS RD**

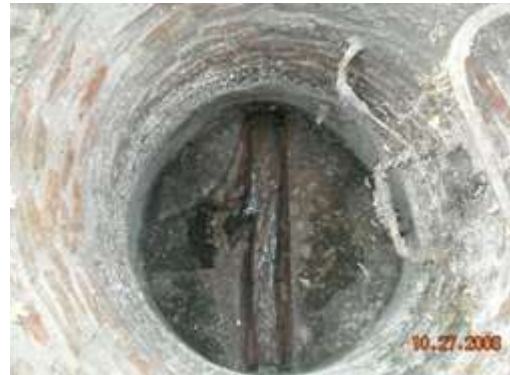
Top View

Corroded and missing steps. Evidence of surcharge - Bench debris. Channel debris.

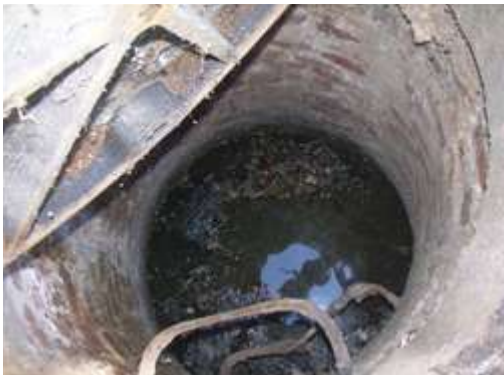
Top View

Active surcharge - 1st visit.

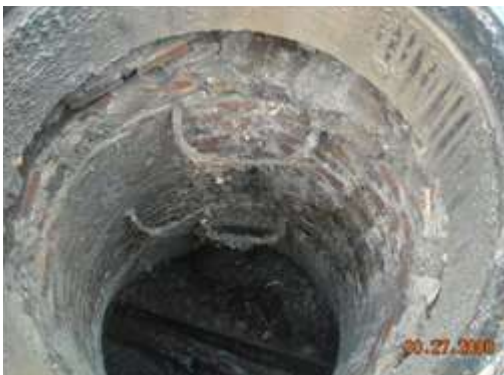
Defect

Frame leaks. Adjustment deterioration, loose brick and infiltration. Corbel infiltration.

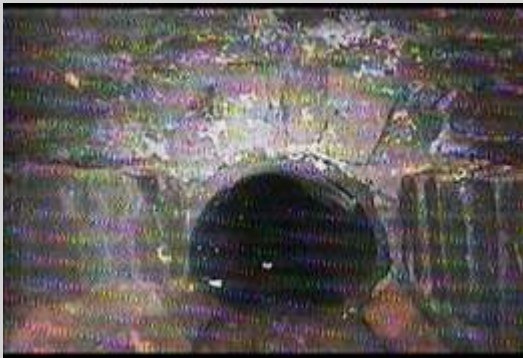
8 in. Circular Gravity Sewer Pipe Out @ 12 O'Clock

Infiltration: **Evidence** Pipe Seal Cond: **Unknown**

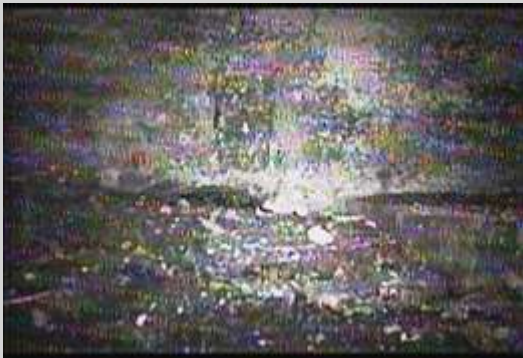
Pipe In @ 9 O'Clock

Connects To: **Stub connection / abandoned**
☐ Possible Illicit Connection
